**A review on oriented fall structures (Earthquake Archaeological Effect, EAE)  
induced by instrumental earthquakes**

*Análisis de caídas orientadas de estructuras (efecto arqueológico de terremotos)  
inducidas por terremotos instrumentales*

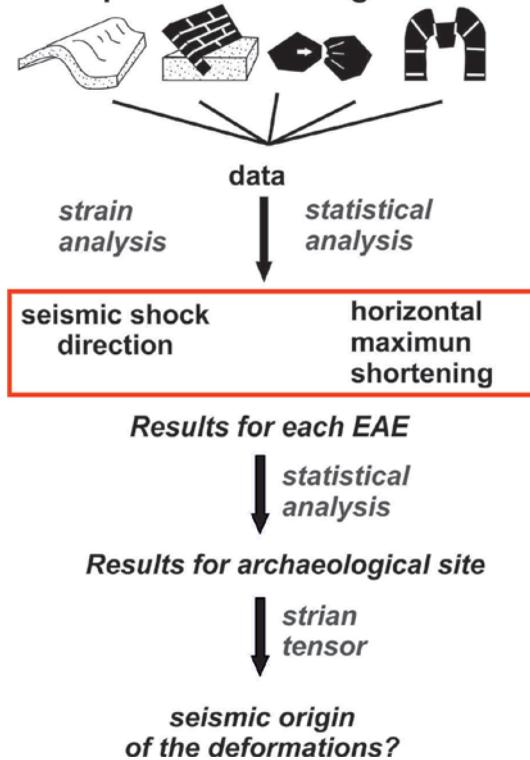
Figure 1. Method diagram proposed by Giner-Robles *et al.* (2009) for the quantitative analysis of strain deformation present in structures on an archaeological site (EAE) (Rodríguez Pascua *et al.*, 2009, 2011).

The methodology used in this paper, developed by Giner-Robles *et al.* (2009, 2011) to analyze seismic-induced strain on building fabric at archaeological sites, involves a number of stages (Fig. 1):

- Damage identification and inventory (geological effects and effects on building fabric).
- Data characterization (type of effect and measurement).

- Strain quantification on each analyzed structure (EAE).
- Analysis of the tensors defined for each EAE (a single result for each EAE recorded at the site) so that the consistency of the data throughout the site depending on the type of EAE can be analyzed.
- Overall site analysis, so that the homogeneity of the entire data-set for a single

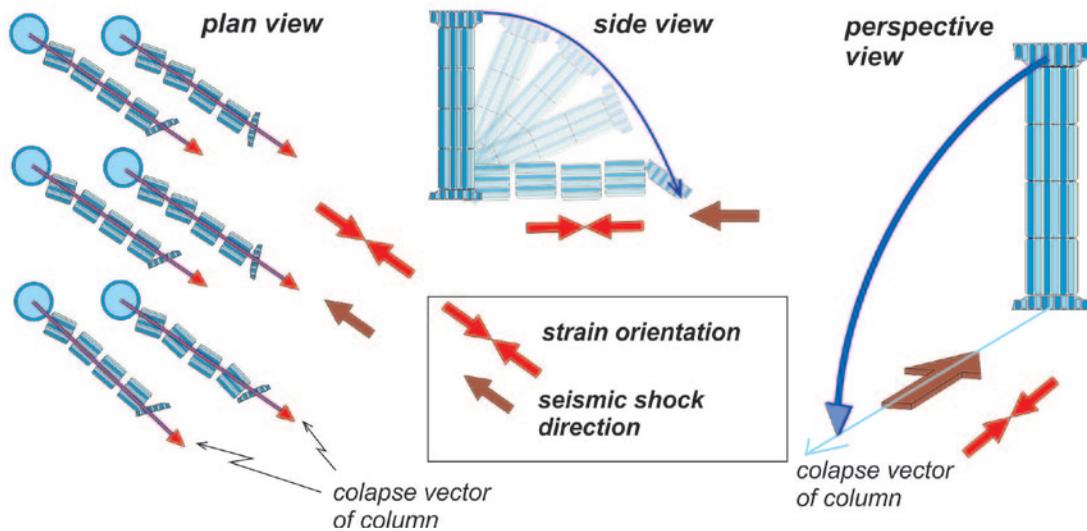
Figure 2. Analysis of structure deformation in oriented column falls. The direction of maximum strain ( $\epsilon_y$ ) is parallel to the orientation in which the columns fall. Damage directionality is defined by the sense in which the column falls (Giner-Robles *et al*, 2011).

In archaeoseismological analysis, it is very common to consider the oriented fall of columns as an evidence of near-field seismic activity (Nur and Ron, 1996; Stiros, 1996). Many authors consider that oriented fallen columns indicate the arrival direction of surface seismic waves; i.e. columns fall in the opposite direction to that of the arriving seismic waves (Fig. 2; Nur and Ron, 1996). Some authors consider that the orientation of fallen can significantly be affected by other factors, such as the type of construction (e.g. quality of materials, imperfections), anthropogenic activity (e.g. deliberate destruction) (Ambraseys, 2006; Marco, 2008), or topographic nature (e.g. slopes, escarpments) (Silva *et al.*, 2009). Other authors (Hinzen, 2009; Hinzen *et al.*, 2009) use cyclical movement models of these structures to indicate that small changes in the energy and even duration of the vibration can lead to columns falling in different azimuths. However finite-elements models developed by these authors only consider single and isolated columns and do not take into account that for most of the cases of archaeoseismological damage columns was active structural

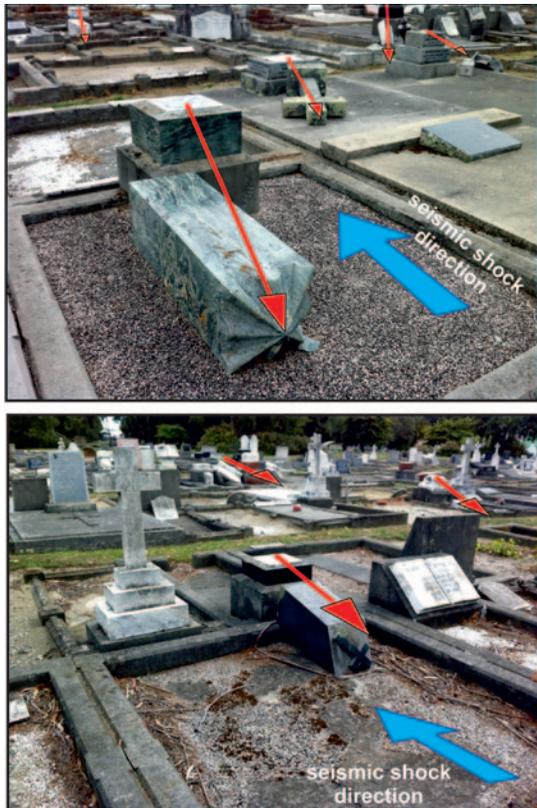
Figure 3. Oriented fallen crosses and obelisks in the Bromley Cemetery (Christchurch, New Zealand) as a result of the earthquakes that struck the town in 2011 and 2012. The azimuth of the falls is the same in the entire cemetery.

ber of columnar structures, obelisks and tombstones (Fig. 3). The recorded orientations of the fallen structures were very homogeneous, with small dispersions due to the particular geometry of the affected structure (e.g. rounded or squared bases). In some cases there were two well defined orientations. They have been provisionally interpreted as the result of the two seismic shocks related to the first and second seismic sequences that struck the city.

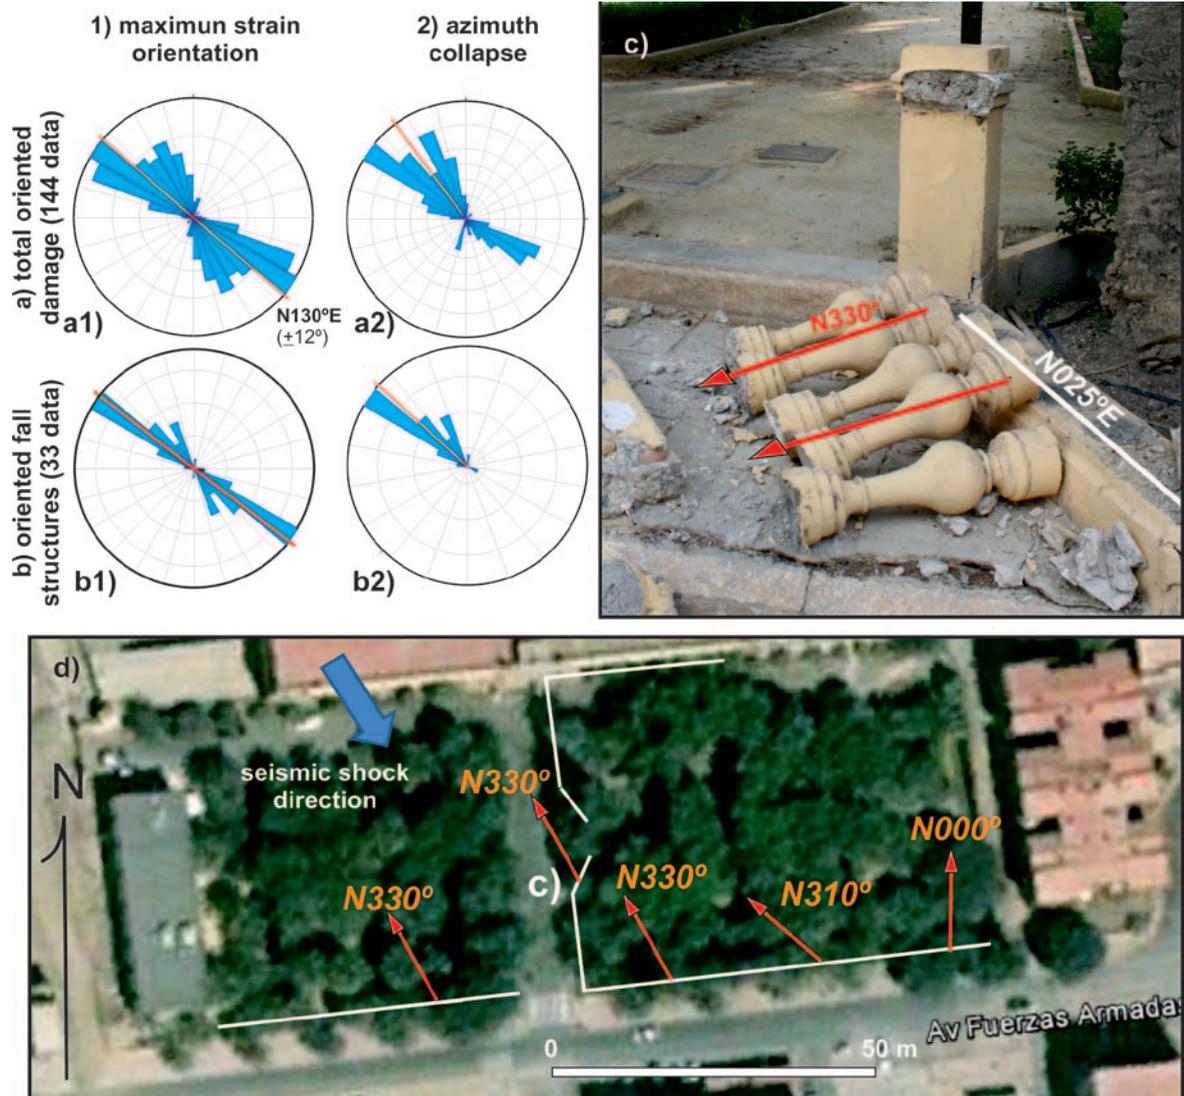
Figure 4. Rose diagrams of maximum deformation ( $\epsilon_y$ ) (1) and azimuth of the collapse structures (2), of all the recorded damages (a) and oriented fall structures (b). c) Detail of a fall on the balustrade in a city park in Lorca. d) Map illustrating the consistency in the measured directions of maximum deformation and in the azimuth of collapse. *Figura 4. Rosas de orientaciones de máxima deformación horizontal ( $\epsilon_y$ ) (1) y de azimuth de caída (2), de todos los daños registrados (a) y sólo de las estructuras de caídas orientados (b). c) Detalle de una caída en la barandilla en un parque de la ciudad de Lorca. d) Mapa que ilustra la consistencia en las direcciones de deformación máxima y de azimuth de caída.*

ted very close to the city (c. 3 km NW Lorca) caused extensive damage of intensity VII EMS (IGN, 2012; Martínez Solares *et al.*, 2012). Among the 140 recorded EAEs (IGME, 2011; Giner-Robles *et al.*, 2012), we analyzed 33 oriented falls structures (chimneys, balustrades, etc.) (Fig. 4).

The various types of damages (EAEs) are distributed homogeneously throughout the city and they display orientation N130°E with very small dispersion (Fig.4a2). This orientation is almost orthogonal to the overall orientation of the Lorca-Alhama de Murcia Fault (LAF), the seismic source of the 2011 event (IGME, 2011; Martínez Díaz *et al.*, 2012), and also coincides with the orientation of the horizontal displacement vectors, as deduced from ground acceleration data (0.37g) recorded by IGN seismic station sited at the Lorca city centre (IGN, 2012; Martínez Díaz *et al.*, 2012). The results of the analysis of the fallen structures present a parallel orientation to the direction of the horizontal displacements recorded during the earthquake (Fig.4b1). The azimuths of all structures can be grouped at N310° (NW) and at N130° (SE). This bimodal distribution on the oriented damage is conditioned by the geographical location of the EAEs in relation to the trace of the seismogenic fault (LAF) NW of the city (Giner-Robles *et al.*, 2012). However, all of the oriented structures have azimuths indicating displacement to the NW, consistent with the location of the fault trace. In spite of in few cases there is some dispersion (Fig.4c and d), most of the recorded orientations are subparallel and consistent with other architectural damage recorded in the city.

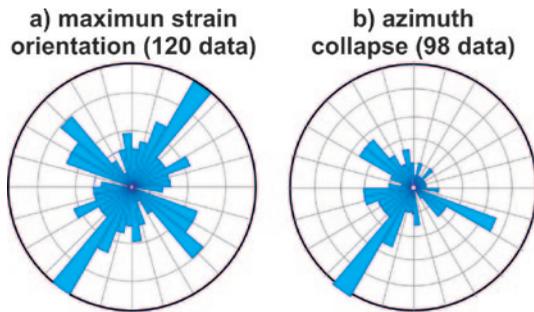
Figure 5. Rose diagrams of maximum deformation (ey) (a) (120 data) and azimuth of the collapse structures (b) (98 data), of all the recorded seismic damages measured (Emilia Romagna, Italy). The data were measured at 14 locations in the Emilia Romagna affected by the two series of earthquakes (30 km around the epicenters).

(Pérez-López *et al.*, 2012). The preliminary analysis of the orientation of maximum deformation (Giner-Robles *et al.*, 2011) displayed two orthogonal directions (N330° and N240°; Fig. 5) that may represent the occurrence of the two main earthquakes or be related to the orientation of the suspect seismic fault.

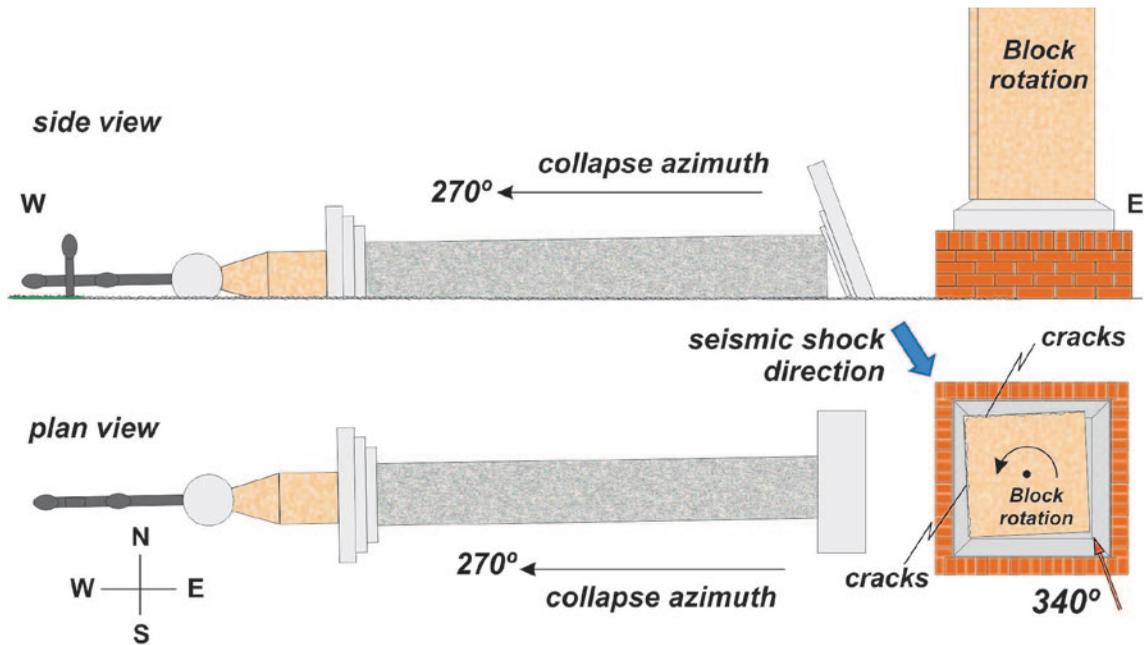
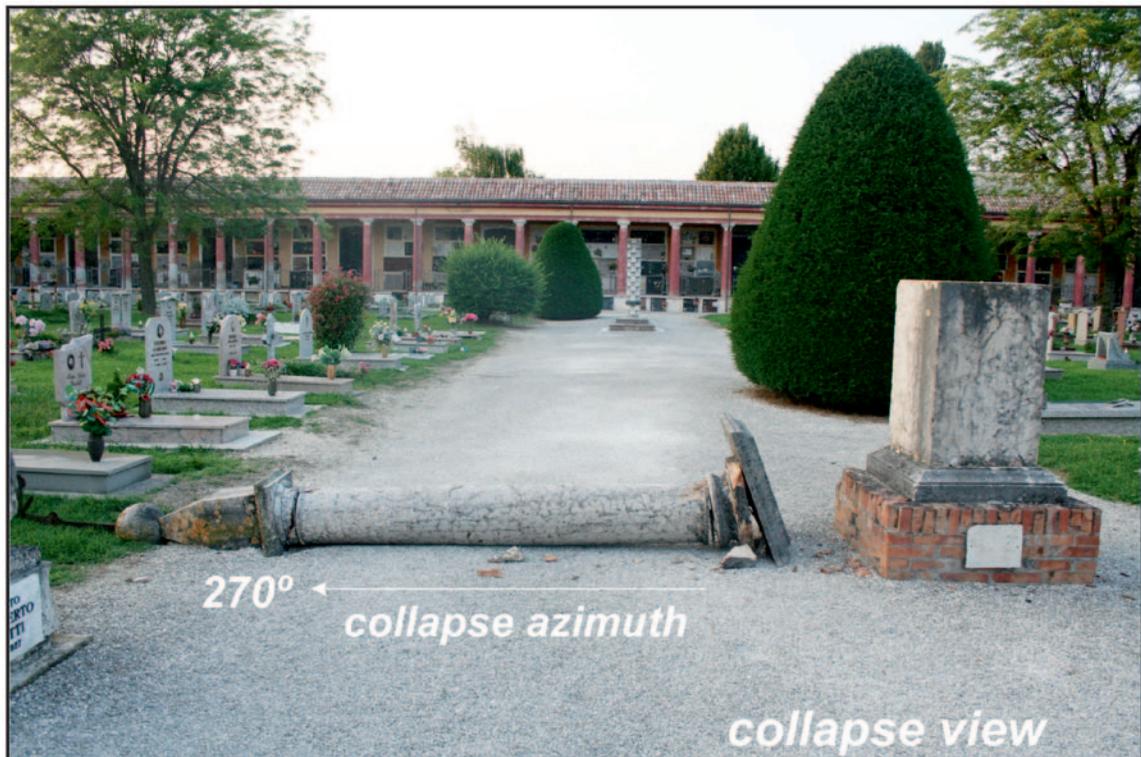
Figure 6. Structure collapsed in the cemetery of Mirandola city (Mai 29 earthquake, Emilia Romagna, Italy). Scheme (a) and photograph (b) of the collapsed structure. The obelisk collapses towards the N270°, while the base undergoes rotation and displacement (N340°).

Orientated obelisk towards N270° is conditioned by the presence of squared slabs between the basement of the monument and the circular base of the overlying obelisk, but is clearly controlled by the seismic shock direction. This orientation (N340°) is clearly observable in the shifted base of the obelisk (Fig. 6a) and in the fall of all the atrium columns in the southern part of the cemetery (Fig. 8).

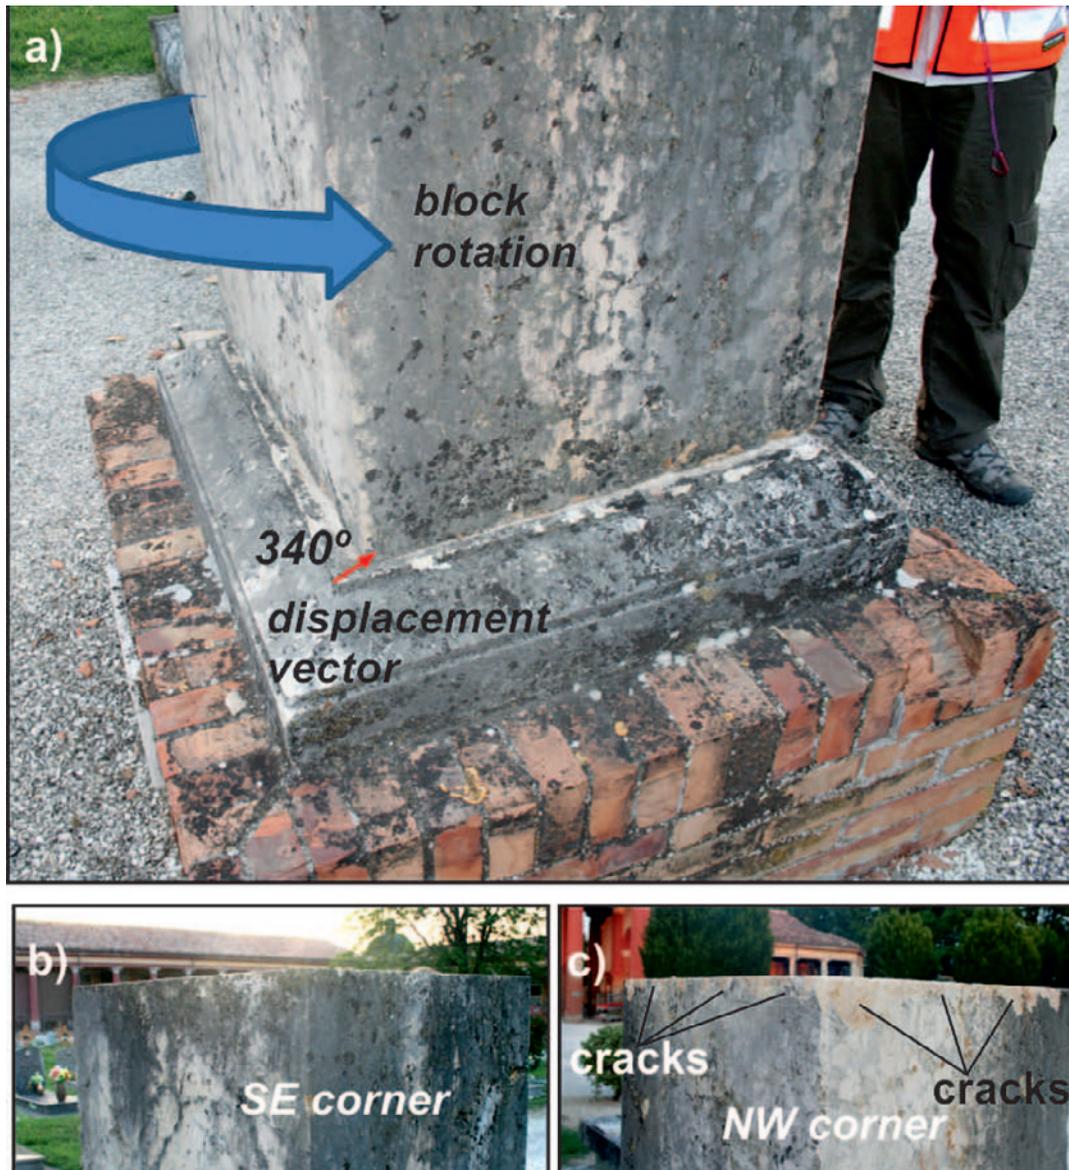
Figure 7. a) View from the SE of the base of the obelisk. Note its rotation and displacement as N340°. Views of the top corners of the obelisk base: the SE corner (b) shows no damage, while the NW corner (c) shows cracks as a result of a NW- oriented seismic shock, parallel to the displacement of the base.

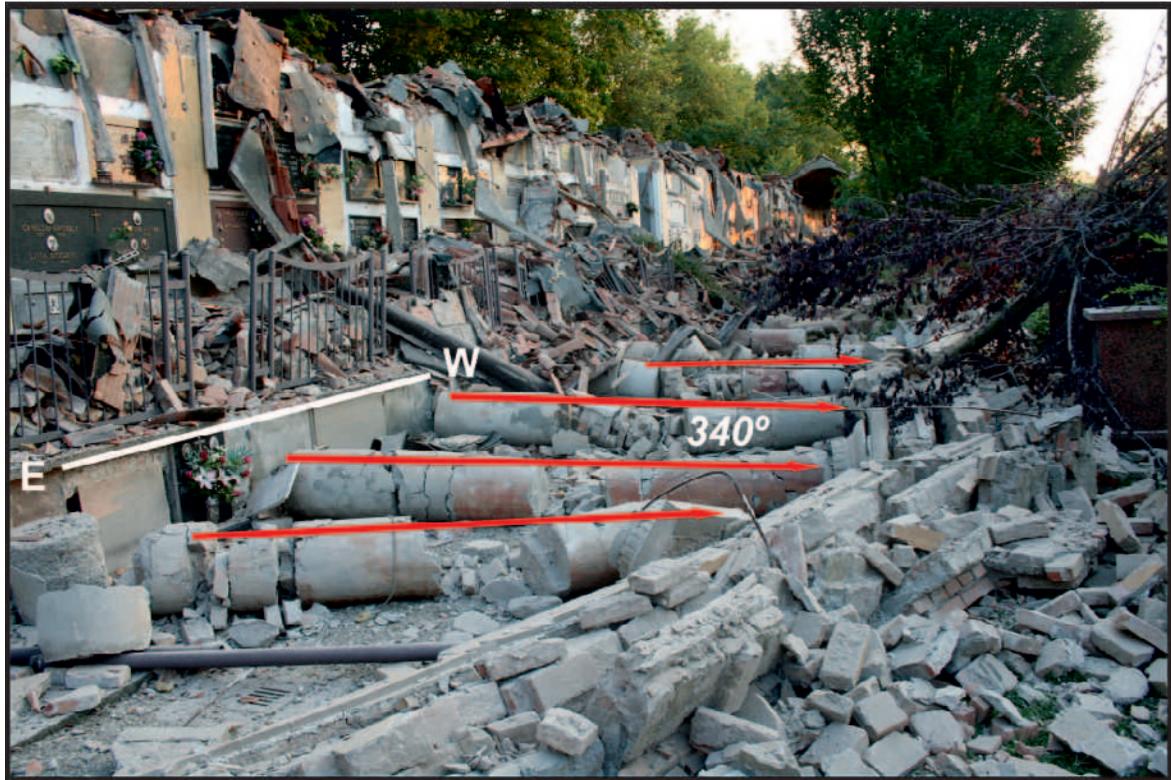
Figure 8. Series of columns collapsed in the cemetery of Mirandola. The azimuth coincides with the displacement vector of the base of the obelisk (see fig.5).

Data presented in this study corresponds to the epicentral area of the second event (5.8 Mw) recorded in the localities of Mirandola and San Giacomo Roncole, located 6 to 7 km NW of the earthquake epicenter, which underwent damage at VII-VIIIEMS Intensity (ISPRA, 2012). In the cemetery of Mirandola, oriented EAEs were observed in single structural elements (e.g. obelisks, tombstones), but also in complex elements such as columned atriums. In the central part of the cemetery there was a fallen obelisk oriented in a N270° azimuth (Fig. 6). A detailed analysis shows that the square base of the obelisk records a rotation and a shift towards N340° (Fig. 7a). It is also observed that the upper northwest corner of the base (Fig. 7c) show a distinctive break-out defining a seismic shock towards NW according to the methodological approach of Giner-Robles *et al.* (2012). Cracks are not observed in the SE corner (Fig. 7b) which is consistent with the displacement vector of the shifted base (N340°). In the south of the cemetery, a battery of columns fell oriented. The columns collapsed obliquely to the direction of the structure with a N340° azimuth (Fig. 8), consistent with the rest of the documented oriented damage.

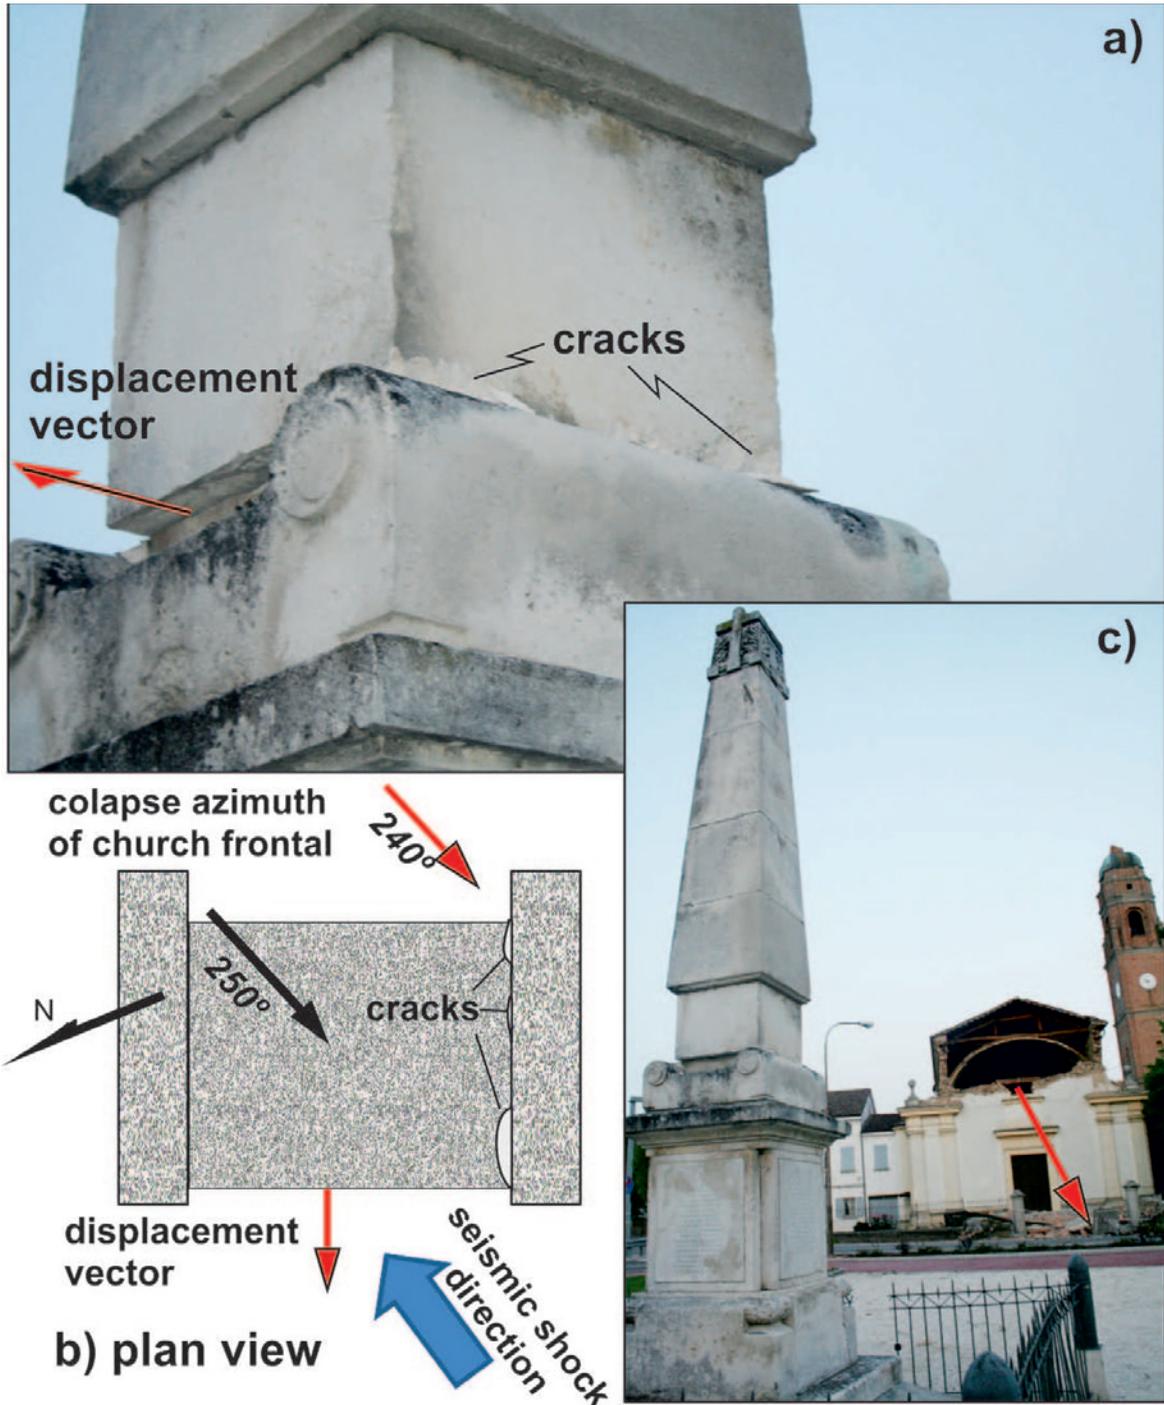
Figure 9. Obelisk in the village of San Giacomo Roncole. Displacement occurred in the only possible direction (a, b), but cracks in the block indicate the direction of the maximum strain, subparallel to the collapse of the facade of the church in the background (c) (N240°).

In the locality of San Giacomo, seismic damage was recorded in a single obelisk placed in the front door of the church's town. In this case, the structure did not collapsed, but clearly shows that the characteristics of the construction might conditioned the direction of displacement of the obelisk. This obelisk has been displaced towards the only possible direction that allows the structure (Figs. 9a and 9b), but the break-outs in the block illustrate the actual orientation of the ground movement (N250°), parallel to the collapse of the gable of the church (N240°) south of the obelisk (Fig. 9c).
