### Recent morphological changes (2009-2022) on the floodplain of the Guadalporcún River, province of Cádiz (Southern Spain)

*Cambios morfológicos recientes (2009-2022) en la llanura de inundación  
del río Guadalporcún, provincia de Cádiz (Sur de España)*

Pain, C.F. (1)

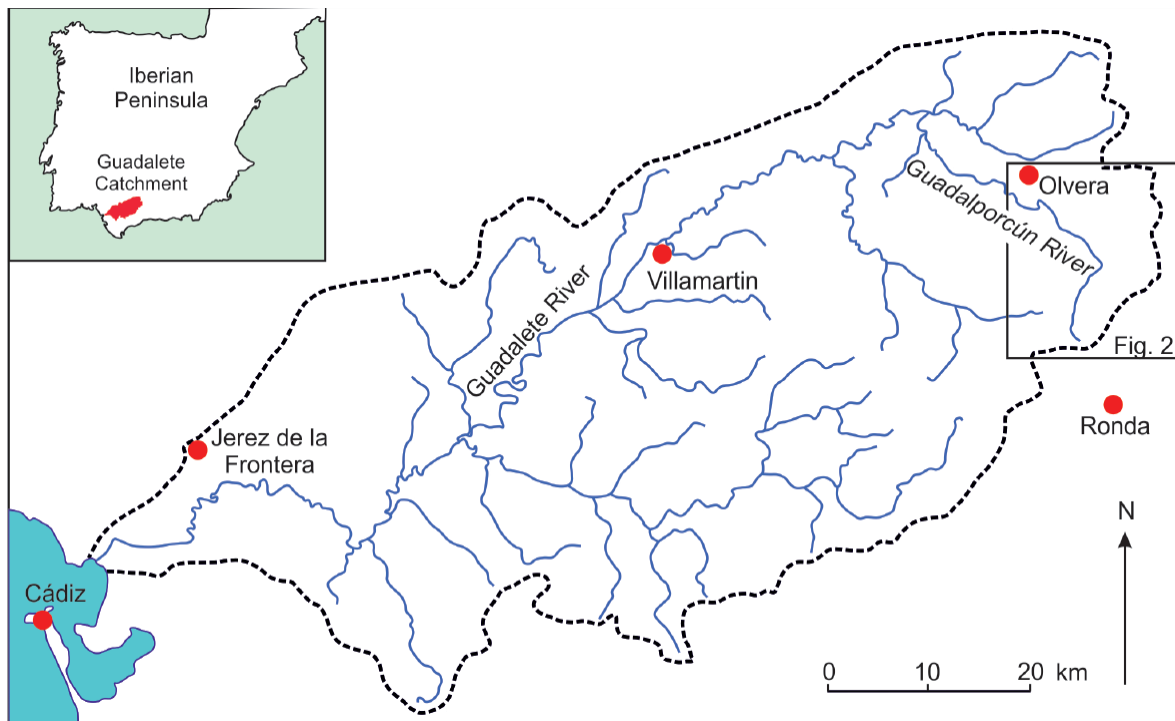
Figure 1. Main drainage lines in the Guadalete River catchment. Location of Figure 2 is shown on the right.  
 Figura 1. Principales líneas de drenaje en la cuenca del Río Guadalete. La ubicación de la Figura 2 se muestra a la derecha.

The Guadalporcún River is a tributary of the Guadalete River, which flows into the Atlantic just northeast of the city of Cádiz in Cádiz Province, southern Iberian Peninsula (Figure 1). The highest parts of the catchment boundary are between 800 and 900 m asl and lie on the eastern edge of the Guadalporcún River catchment, east of Setenil de las Bodegas. The Guadalporcún River exits the study area at about 390 m asl. Upstream of the study area the Guadalporcún River drains an irregular dissected plateau consisting mainly of Tortonian and Messinian limestone, marls, calcarenite, calcareous sandstones, clay, silts, sands, and conglomerate (Cruz-Sanjulián, 1990; del Olmo Sanz and Serrano, 1990; Medina and Jerez Mir, 1990; Serrano, 1990) (Figure 2). The valley floor consists of a series

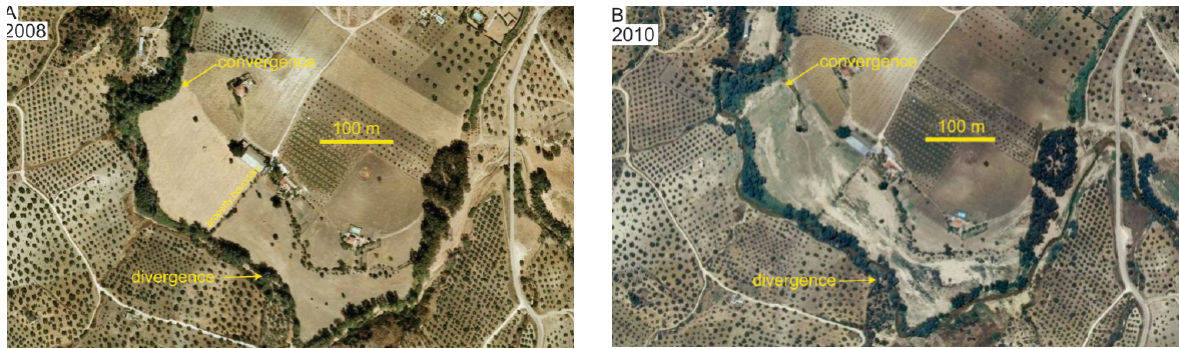
Figure 6. A. GeaMap image from 2008 showing the area before the flooding events. B. GeaMap image from 2010 showing the area following earthworks on the floodplain and at the divergence point. The remnants of the downstream end of the avulsion channel can be seen leading to the convergence point. Cropping on the floodplain resumed after this date.

*Figura 6. A. Imagen de GeaMap de 2008 que muestra el área antes de las inundaciones. B. Imagen de GeaMap de 2010 que muestra el área después de los movimientos de tierra en la llanura aluvial y en el punto de divergencia. Se pueden ver los restos del extremo aguas abajo del canal de avulsión que conducen al punto de convergencia. El cultivo en la llanura aluvial se reanudó después de esta fecha.*

During floods this channel carries water onto the floodplain, but no erosion appears to have resulted from either the 2009 or 2013 floods. Figure 6A shows the floodplain in 2008 about a year before the first flood; the old irrigation channel is marked by the irregular line of trees extending to about halfway down the floodplain.

On 22 December 2009 a flood broke through a low levee on the right bank at the divergence point (Figure 3) and flowed across the lowest part of the floodplain. By 24 December flood waters had covered the entire floodplain, and by 26 December the flood waters had receded, leaving a shallow (> 50 cm) channel on the floodplain. The flood also left an incipient gully near the convergence point, and a knick-point began to develop (Figure 6B). Most flow

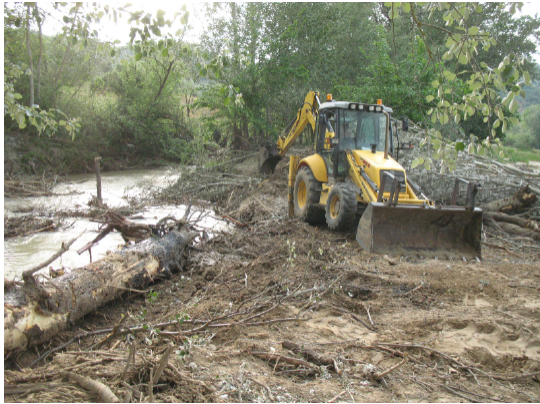
Figure 7. Rebuilding the levee and diverting the river back to its original channel at the divergence point in April 2010.

*Figura 7. Reconstrucción del dique y desviación del río a su cauce original en el punto de divergencia en abril de 2010.*

was returned to the original channel. The base of the floodplain channel was formed by the buried soil within the floodplain sediments. In April 2010 the levee was artificially rebuilt at the divergence point and during the following months the shallow avulsion channel was artificially filled (Figure 7). This work was carried out by the owner of the down-

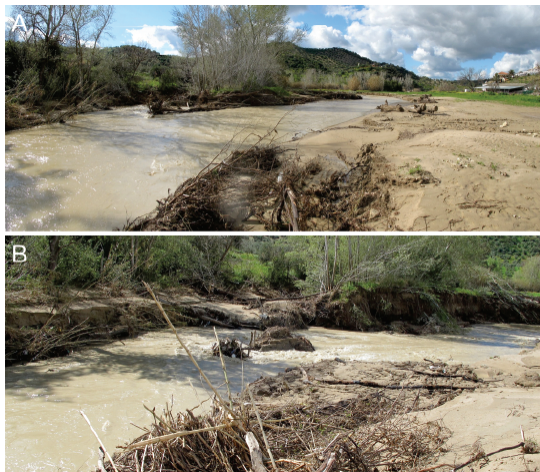
Figure 8. A. The divergence point on 20 March 2013 looking downstream. The original channel continued to flow on the left but most water flowed down the avulsion channel on the right. B. The divergence point on 4 April 2013. The new channel has cut about 1 m below the old channel, which was then abandoned. B also shows the nature of the original levee (photos: Jenny Stock).

*Figura 8. A. El punto de divergencia el 20 de marzo de 2013 mirando corriente abajo. El canal original siguió fluyendo por la izquierda, pero la mayor parte del agua fluyó por el canal de avulsión de la derecha. B. El punto de divergencia el 4 de abril de 2013. El nuevo canal ha cortado aproximadamente 1 m por debajo del antiguo canal, que luego fue abandonado. B también muestra la naturaleza del dique original (fotos: Jenny Stock).*

Another major flood occurred in March 2013. On 20 March 2013 the repaired levee at the divergence point was breached and the avulsion channel on the floodplain was re-established (Figure 8A). By 4 April 2013

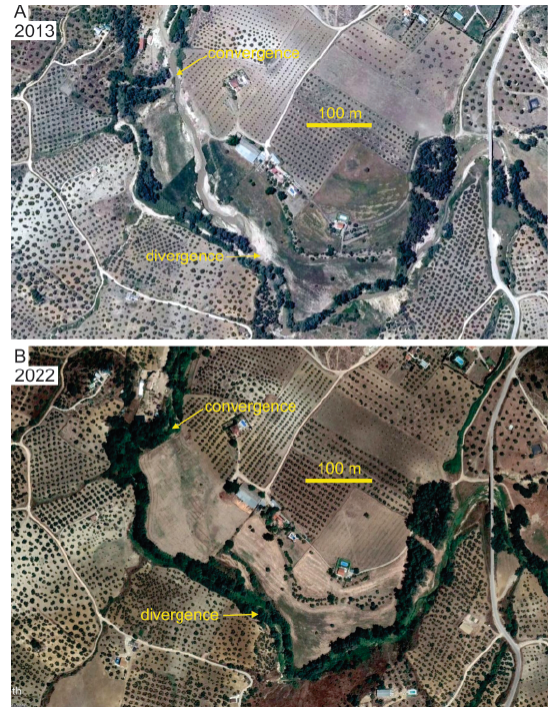
Figure 9. A. GeaMap image showing the avulsion channel in mid-2013. Note the light-coloured flood sediments along the old irrigation channel. B. Google Earth image from 2022. The downstream property has been levelled, the levee at the divergence point has been repaired and the river has been returned to its former location. The avulsion channel fill shows as slightly darker tones. The avulsion channel on the upstream property is lined with low trees but has not been levelled.

*Figura 9. A. Imagen de GeaMap que muestra el canal de avulsión a mediados de 2013. Tenga en cuenta los sedimentos de inundación de color claro a lo largo del antiguo canal de riego. B. Imagen de Google Earth de 2022. Se niveló la propiedad aguas abajo, se reparó el dique en el punto de divergencia y se devolvió el río a su ubicación anterior. El relleno del canal de avulsión se muestra como tonos ligeramente más oscuros. El canal de avulsión en la propiedad aguas arriba está bordeado de árboles bajos pero no ha sido nivelado.*

the avulsion channel was eroded to about 2 m depth below the floodplain surface; this led to the original channel being abandoned because it was left standing about 0.5-1 m above the bed of the new channel (Figure 8B). The new channel was up to 20 m wide near the divergence point and narrowing to about 5 m wide at the convergence point (Figure 9A).

Following the 2013 flood all floodplain changes were a consequence of artificial interventions. The landowner of the downstream property began to fill the downstream part of the avulsion channel, using building rubble from the nearby village of Olvera. Filling began at the downstream end and led to ponding of the channel at the upstream end. This work was accompanied by repair of the levee at the divergence point. By 2021 the Guadalporcún River was back in its original channel and the whole of the downstream property had been graded and cropping resumed (Figure 9B).

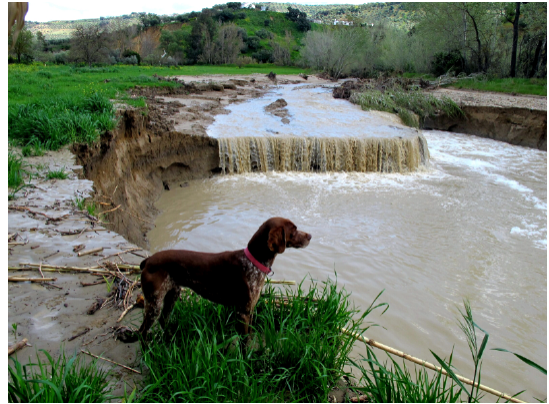
Figure 10. Knickpoint on the avulsion channel on 31 March 2013. Note the light-coloured alluvium at the top on both sides of the channel. Upstream from the knickpoint the water is flowing on top of the buried soil. The original and natural levee, with trees, can be seen on the top right. (Photo: Jenny Stock).

*Figura 10. Knickpoint en el canal de avulsión el 31 de marzo de 2013. Obsérvese el aluvión de color claro en la parte superior a ambos lados del canal. Aguas arriba del knickpoint, el agua fluye sobre la tierra enterrada. El dique original y natural, con árboles, se puede ver en la parte superior derecha. (Foto: Jenny Stock).*
